### **2024-73 Tower Painting Project Addendum #1 – June 4, 2024**

August 2022

Will County Radio  
Frankfort, IL  
ASR: 1245556

**SUBJECT: TOWER MAINTENANCE INSPECTION**  
**Frankfort, IL**  
**200' Rohn SSVMW Self Supporting Tower**

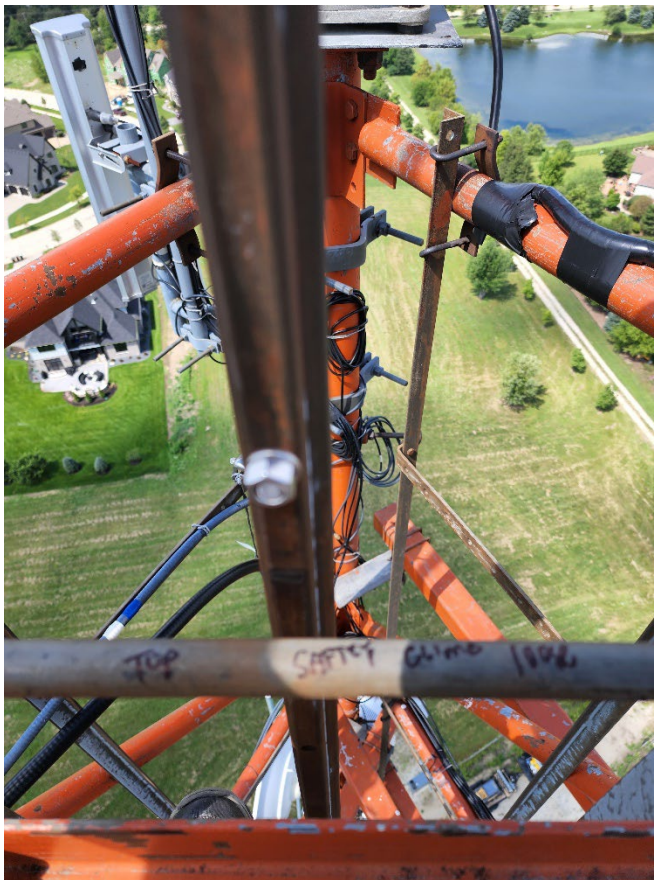
issue 1, top safety climb support missing, this is a non-standard anti climb, and we suggest replacing with a newer model

| 4 Climbing Facilities, Platforms, Catwalks<br>- All secure | <b>Issue 1</b> | Top support missing on safety climb. Several step bolts missing. |

| <b>Category</b> | <b>Item #</b> | <b>Issue</b> | <b>Status &amp; Recommendation</b> | <b>Photo #</b> |
|---|---|---|---|---|
| Tower | 1 | Safety Climb | Missing top support, substandard system – we suggest replacing with new. | Issue 1 |

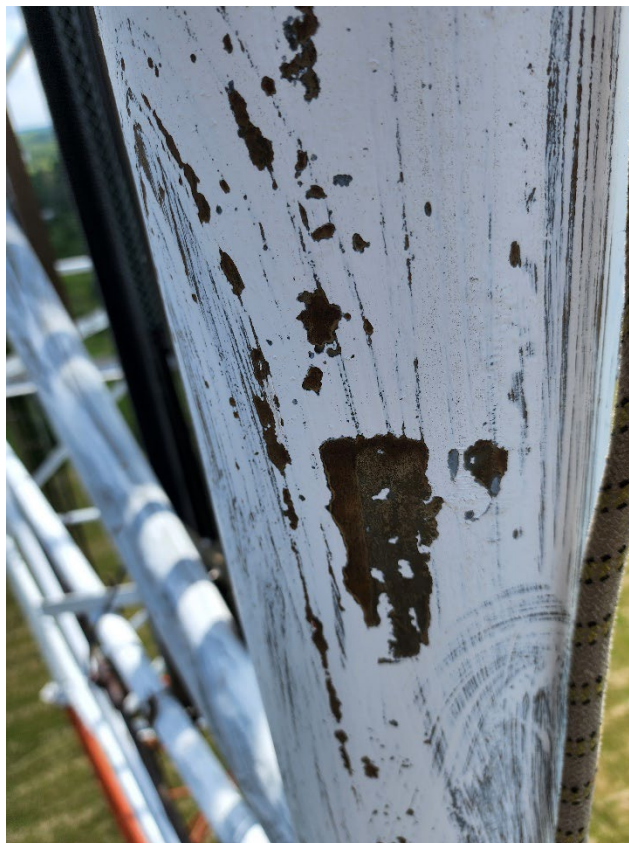
issue 2 – paint condition poor

| 2 Rust and/or corrosion | <b>Issue 2</b> | Minor to major conduit and tower corrosion is occurring in areas. Recommended that all rust scale is coated wit anchor zinc dust paint. <a href="https://anchorpaint.com/product/zinc-dust-primer-1716/">https://anchorpaint.com/product/zinc-dust-primer-1716/</a> |

| <b>Category</b> | <b>Item #</b> | <b>Issue</b> | <b>Status &amp; Recommendation</b> | <b>Photo #</b> |
|---|---|---|---|---|
| Tower | 2 | Tower Corrosion | Tower needs painting to prevent further corrosion. | Issue 2 |

| 1 Paint and/or galvanizing | <b>Issue 2</b> | Recommend painting the tower with Anchor paint.<br><a href="https://anchorpaint.com/product/flexi-coat-aviation-coatings-aa4515/">https://anchorpaint.com/product/flexi-coat-aviation-coatings-aa4515/</a> |

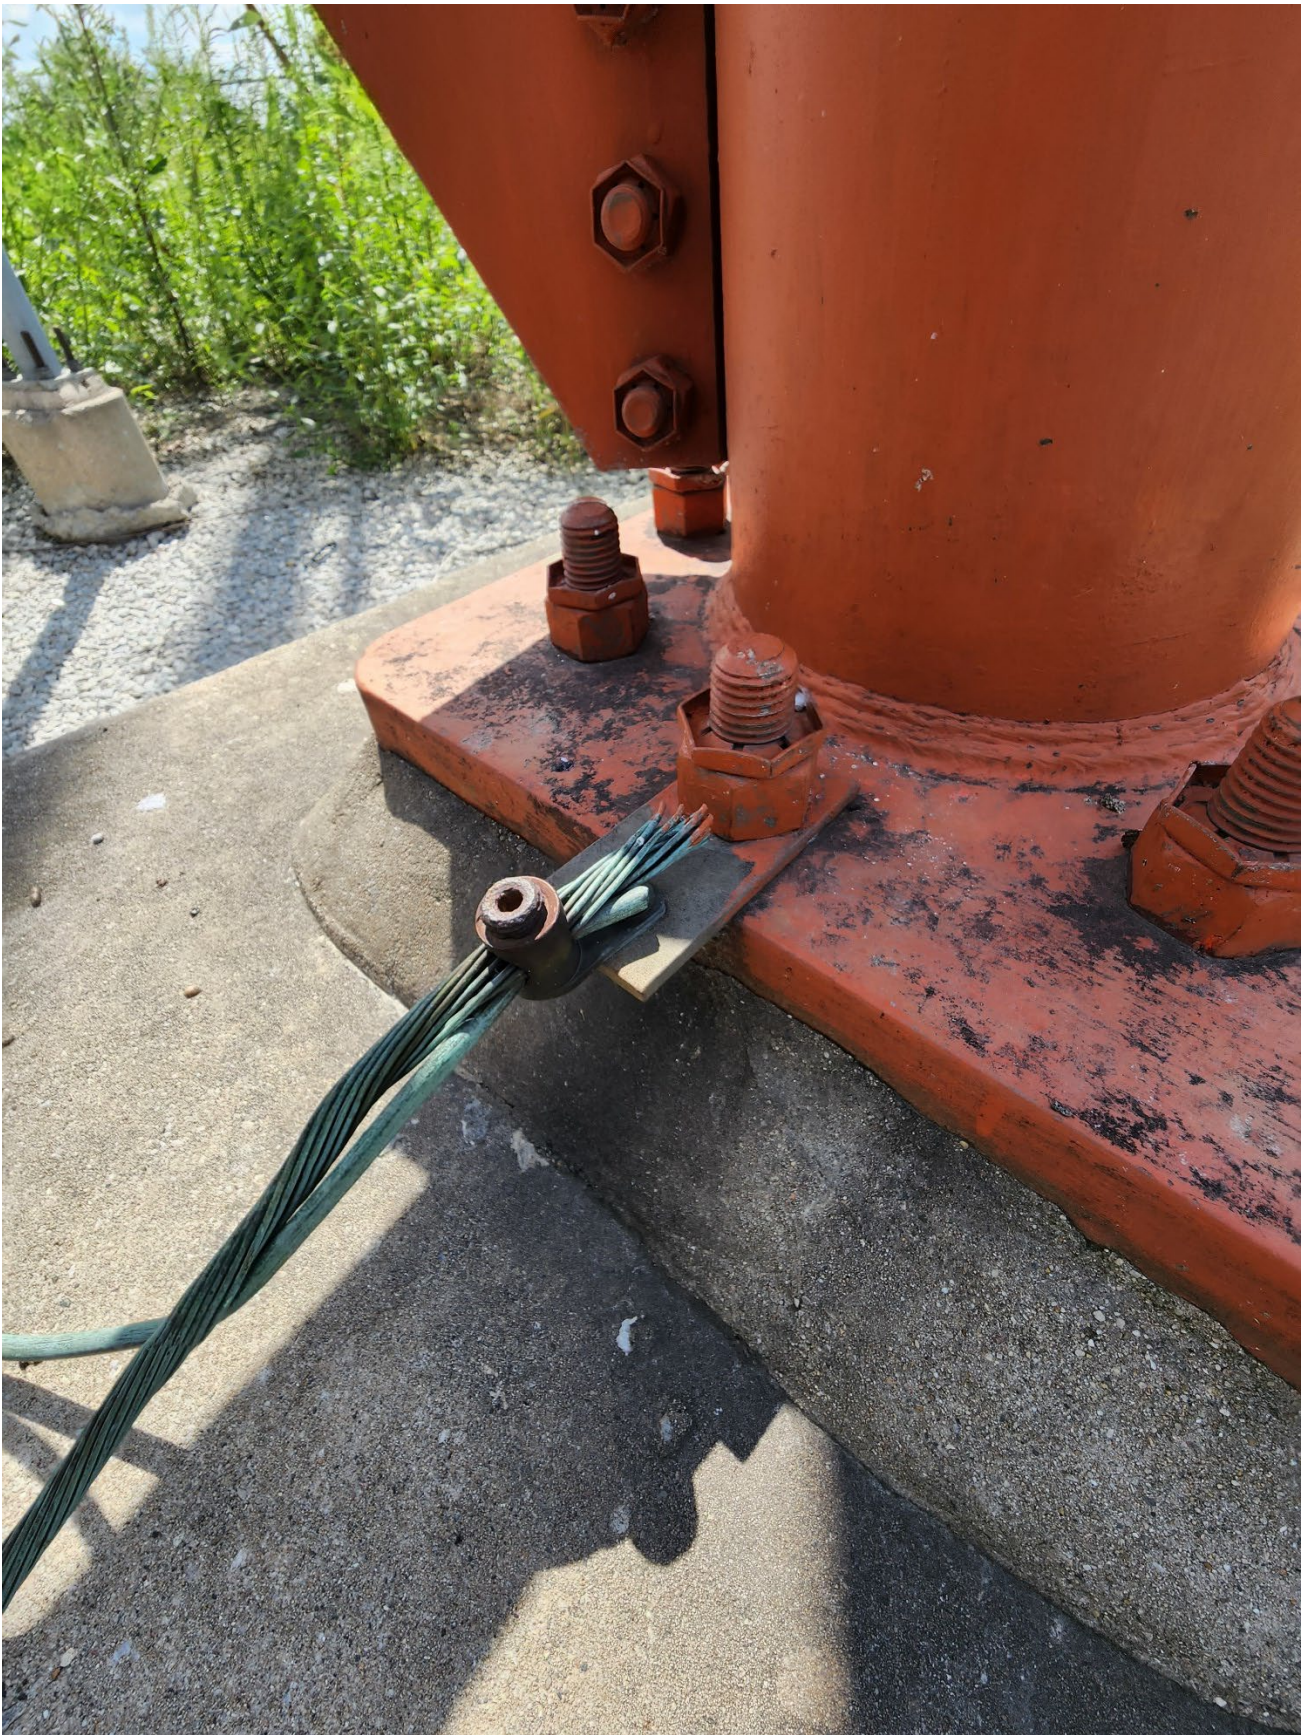
Issue 3 – base grounds needs to be cadweled

| 1 Connections checked and secure | <b>Issue 3</b> | Tower main base connections should be cadwelded |

| <b>Category</b> | <b>Item #</b> | <b>Issue</b> | <b>Status &amp; Recommendation</b> | <b>Photo #</b> |
|---|---|---|---|---|
| Tower | 3 | Grounding @ base | We suggest cad-welding main tower grounds | Issue 3 |

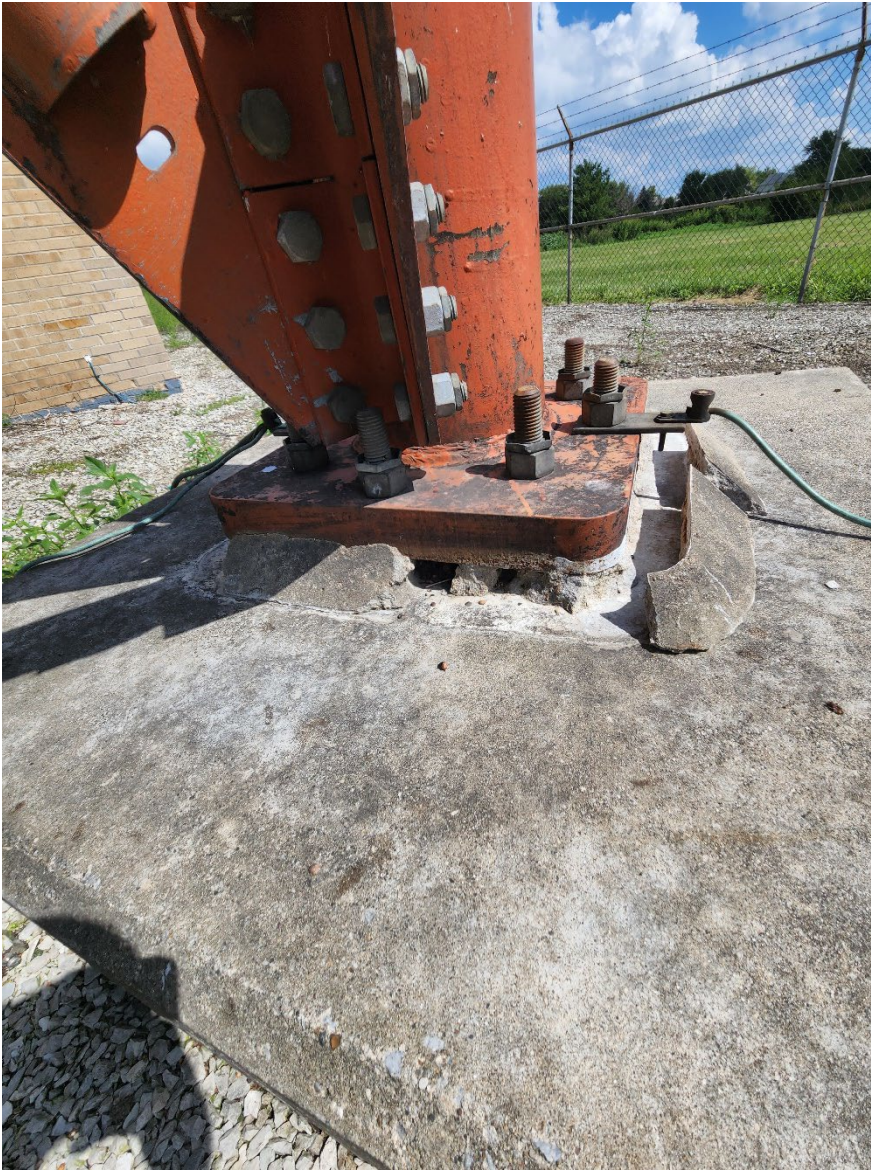
Issue 4 Grout needs repair

| Item | Condition | Notes |
|---|---|---|
| b. Grout condition | Issue 4 | Grout is cracked and/or missing. We suggest this be repaired. |

| <b>Category</b> | <b>Item #</b> | <b>Issue</b> | <b>Status &amp; Recommendation</b> | <b>Photo #</b> |
|---|---|---|---|---|
| Tower | 4 | Grout | We suggest re-grouting tower legs | Issue 4 |

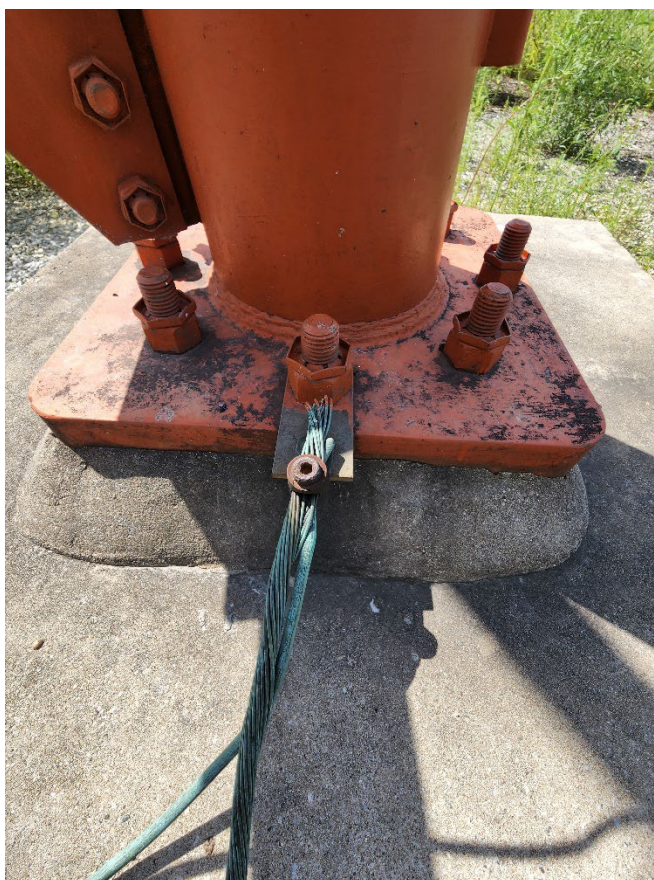
6. **Anchor bolt rot.** Recently there has been tower failures due to anchor bolt rot between the tower foundation and base section due to grout trapping water (which on a pipe leg tower drains down the inside and exits through drain holes in the grout). It is my suggestion a section of grout be removed to reveal the anchor bolts that have been buried since the tower was erected and inspected for rust.

Issue 5 Anchor bolt inspection, water could be getting trapped

| <b>Category</b> | <b>Item #</b> | <b>Issue</b> | <b>Status &amp; Recommendation</b> | <b>Photo #</b> |
|---|---|---|---|---|
| Tower | 5 | Anchor bolt inspection | We suggest pulling grout, inspecting anchor bolts then re-grouting | Issue 5 |

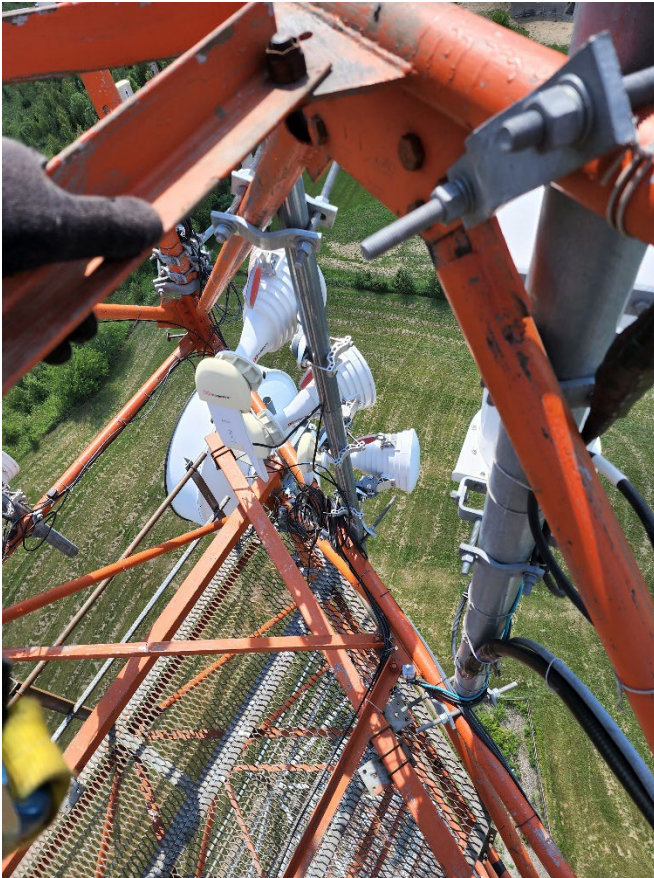
Issue 6 – wi fi clamps should be Valmont Pucks or cross over clamps

Issue 6 wi fi clamps should be replaced

| Item | Condition | Notes |
|---|---|---|
| b. Loose - | ISSUE<br>6 | Wi-Fi mounts secured with substandard clamps, suggest<br>crossovers be utilized.<br><a href="https://www.sitepro1.com/store/cart.php?m=product_detail&amp;p=1999">https://www.sitepro1.com/store/cart.php?m=product_detail&amp;p=1999</a> |

| <b>Category</b> | <b>Item #</b> | <b>Issue</b> | <b>Status &amp; Recommendation</b> | <b>Photo #</b> |
|---|---|---|---|---|
| Tower | 6 | Wi-Fi clamps | Un Standardized clamps were used for WI fi antennas, we suggest they be changed out with Valmont pucks. | Issue 6 |

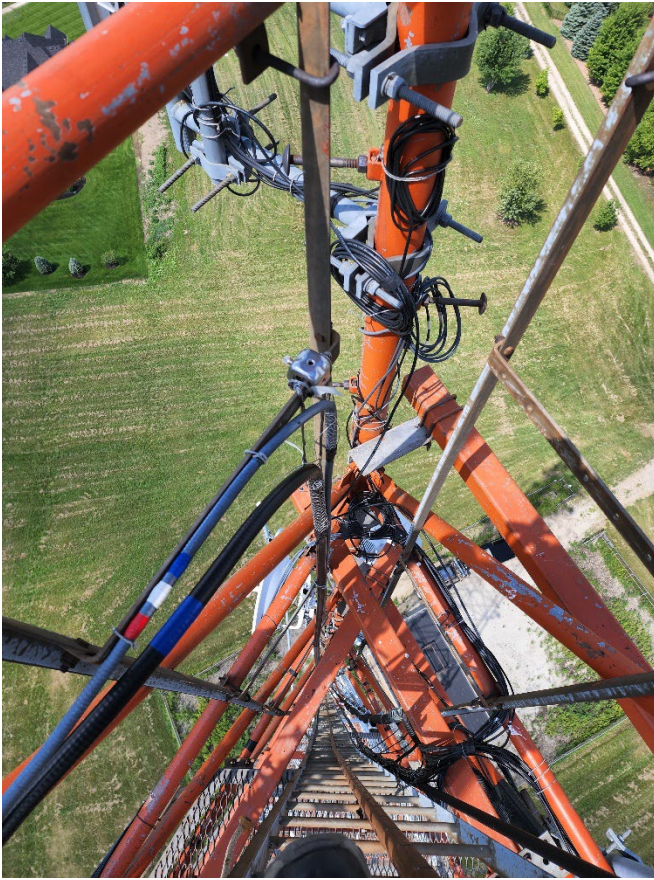
Issue 7 – wi fi quality, poorly supported wires, many unused

| Item | Condition | Notes |
|---|---|---|
| b. Quality | Issue<br>7 | Much all the Wi-Fi antenna cabling is hap-hazardly installed and needs to be neatly re-supported. |

| <b>Category</b> | <b>Item #</b> | <b>Issue</b> | <b>Status &amp; Recommendation</b> | <b>Photo #</b> |
|---|---|---|---|---|
| Tower | 7 | Wi-Fi Quality of work | We suggest the Wi-Fi work be cleaned up and un-used equipment be removed | Issue 7 |

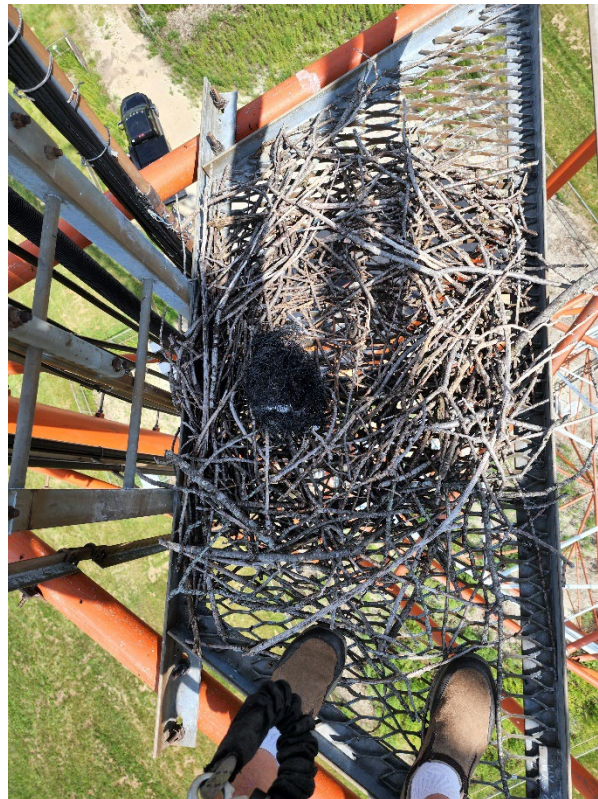
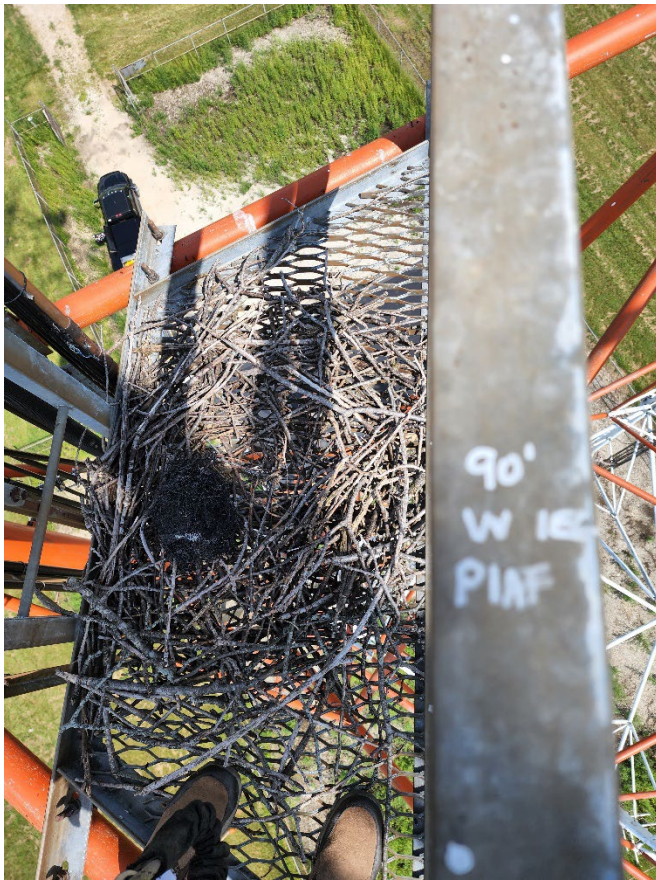
Issue 8 – hawks Nest @ 90', monitor as needed

Issue 8 Hawks nest @ 90' Climbing leg

| #8 | Hawks are starting to build a nest at the rest platform 1/3 of the way up. Recommended to be removed or monitor. |

| <b>Category</b> | <b>Item #</b> | <b>Issue</b> | <b>Status &amp; Recommendation</b> | <b>Photo #</b> |
|---|---|---|---|---|
| Tower | 8 | Hawks Nest | We suggest monitoring the hawk's nest | Issue 8 |

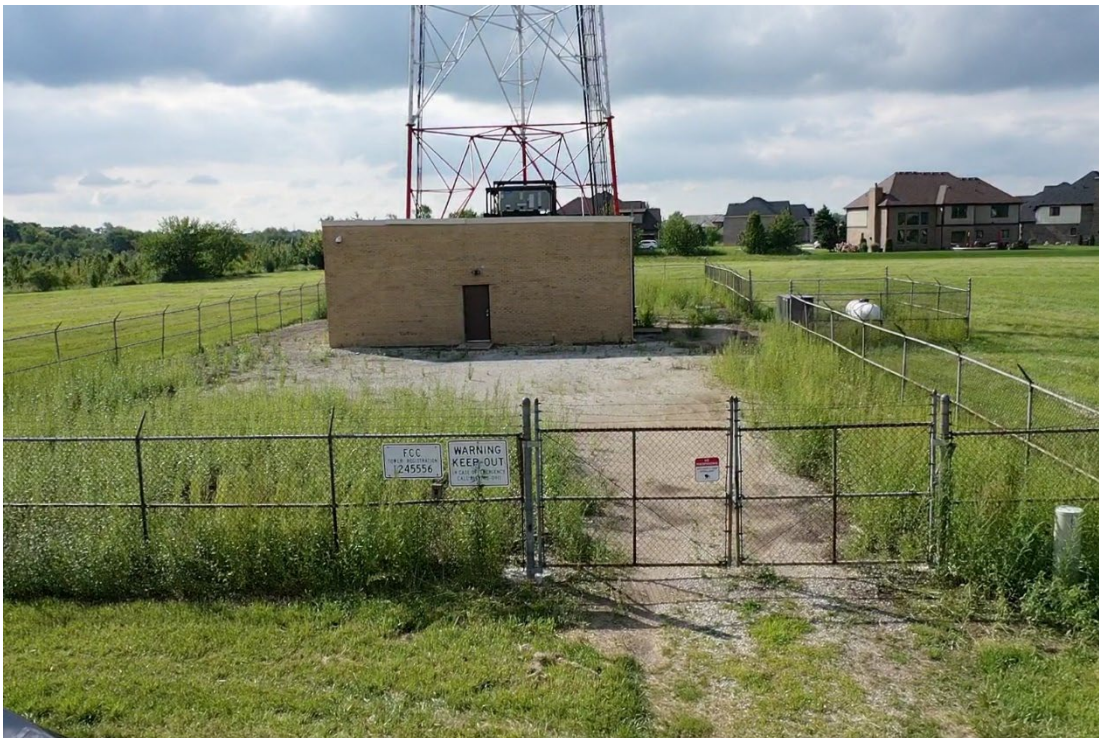
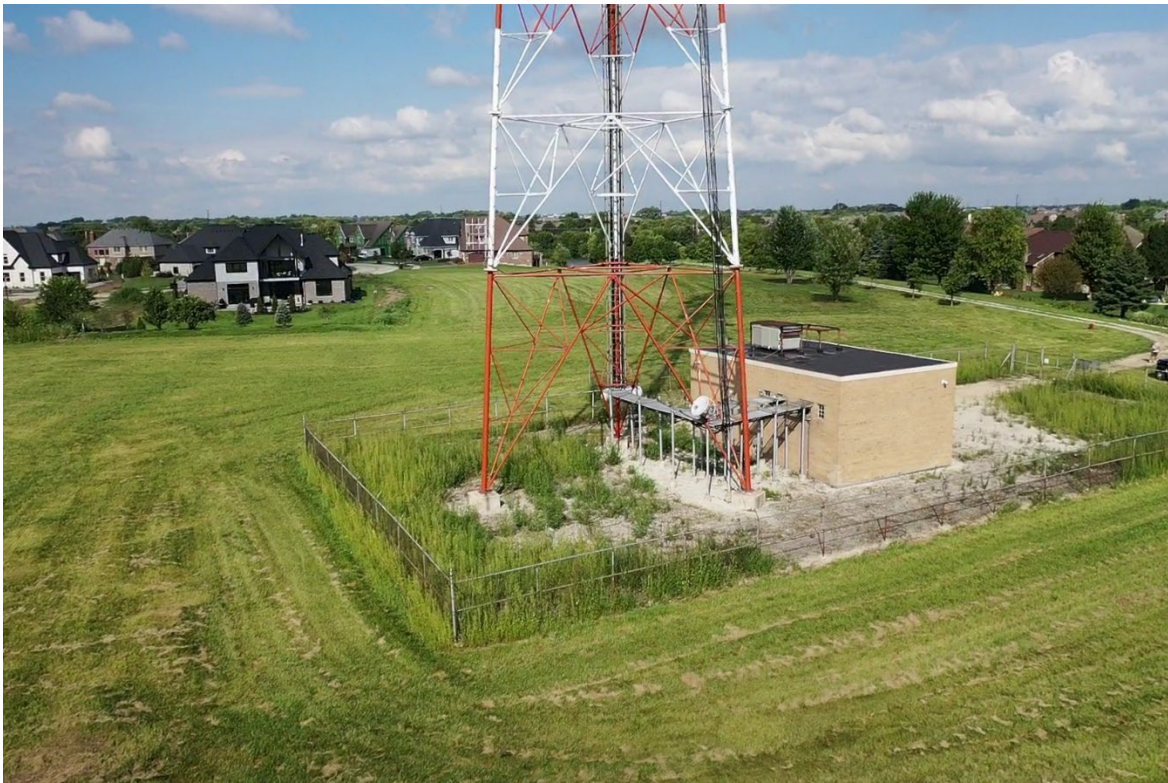
Issue 9 Weed Control needed, not just periodic spraying but a full soil neutralization program with quarterly sprays

Issue 9 Weed Control

| <b>Category</b> | <b>Item #</b> | <b>Issue</b> | <b>Status &amp; Recommendation</b> | <b>Photo #</b> |
|---|---|---|---|---|
| Site Area | 9 | Weeds | We suggest a weed control program be implemented whereas you are not just killing existing weeds but sterilizing the ground for future growth. | Issue 9 |

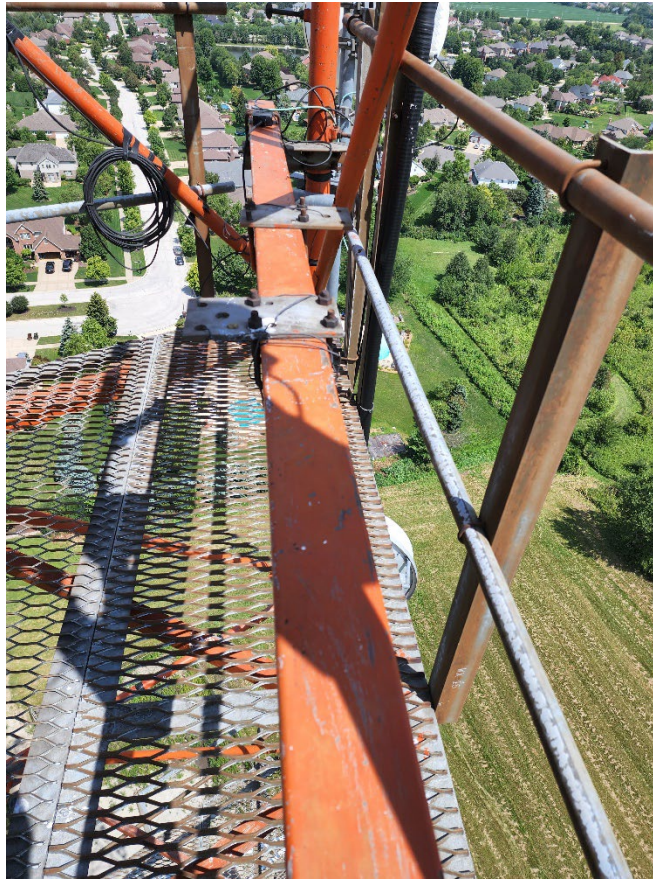
Issue 10 – removal of old equipment (mounts, tie backs, cables etc.)

| Tower | 10 | Equipment removal | We suggest removing unused equipment from the tower | Issue 10 |
