2025-78 Radio Tower Painting

Addendum #1 – May 27, 2025

**SUBJECT: TOWER MAINTENANCE INSPECTION
Frankfort, IL
200' Rohn SSVMW Self Supporting Tower**

Per your request MidAmerica Towers, Inc. (MTI) has completed a TIA/EIA Tower Maintenance Inspection of the existing 200' self-support tower owned by Will County and located in Frankfort, IL.

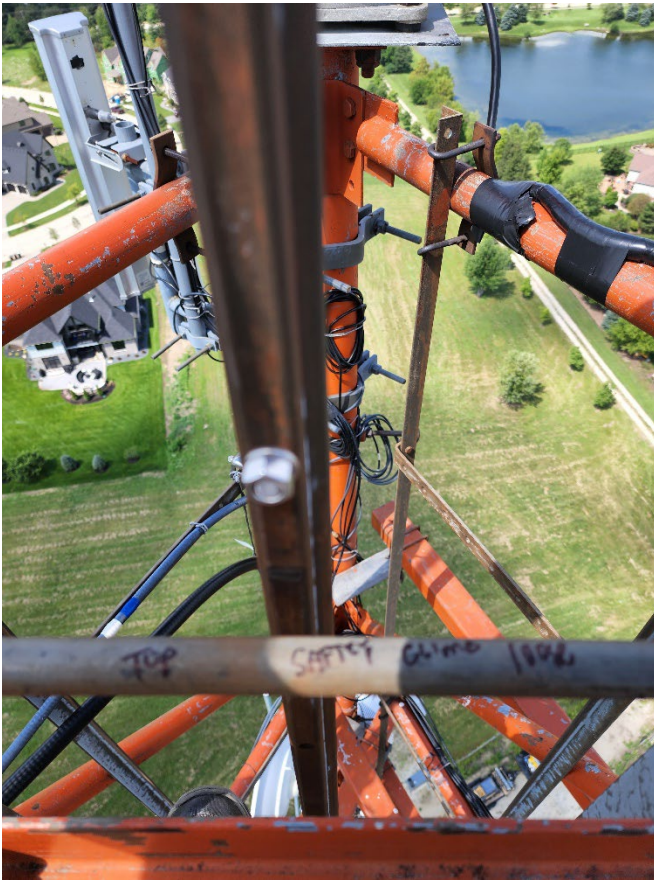
issue 1, top safety climb support missing, this is a non-standard anti climb, and we suggest replacing with a newer model

Item	Condition	Notes
I. Tower Conditions		
A. Members		
1 Bent Members	OK	
2 Loose Members	OK	
3 Missing Members	OK	
4 Climbing Facilities, Platforms, Catwalks - All secure	Issue 1	Top support missing on safety climb. Several step bolts missing.
5 Loose/Missing Bolts	OK	
6 Visible Cracks in welded connections	OK

5. **Safety climb systems can wear, rust, or become outdated.** The safety climb system on this tower is a rail type system, it is highly unlikely a tower climber will have the slide needed to utilize this system. This, along with age I suggest changing the safety climb system out with a newer stainless steel cable system which is the industry standard.

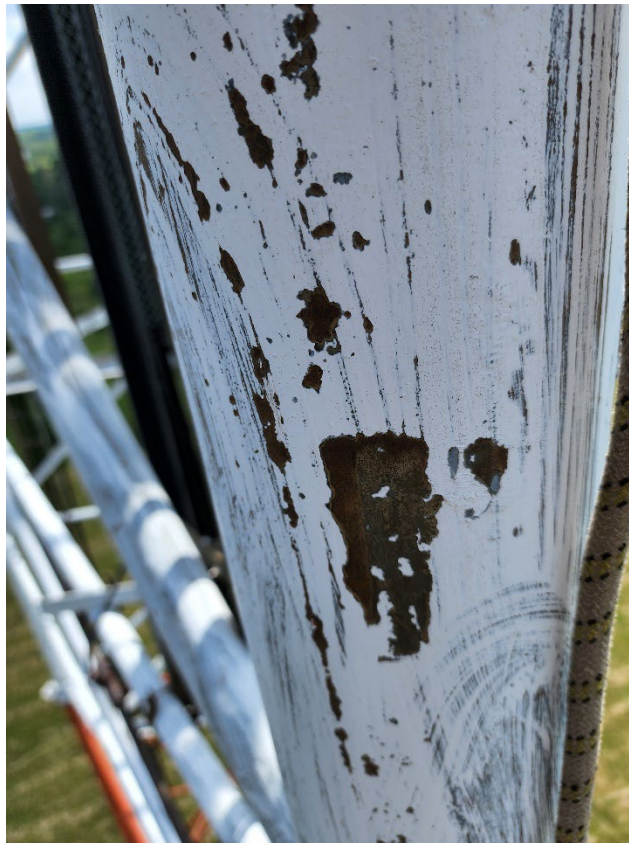
issue 2 – paint condition poor

B. Finish		
1 Paint and/or galvanizing	Issue 2	Recommend painting the tower with Anchor paint. https://anchorpaint.com/product/flexi-coat-aviation-coatings-aa4515/
2 Rust and/or corrosion	Issue 2	Minor to major conduit and tower corrosion is occurring in areas. Recommended that all rust scale is coated wit anchor zinc dust paint. https://anchorpaint.com/product/zinc-dust-primer-1716/
3 FAA or ICAO color marking condition	Issue 2	Tower FAILS FAA color match
4 Water collection in members	OK

2. **Galvanized structural material can bleed a slight rust** color indicating the galvanization is wearing. This tower has little indication of galvanization issues however, the galvanizing shows age and should be coated with a superior quality self-etching coating such as this product from Anchor paint (which has stood the test of time). <https://anchorpaint.com/product/flexi-coat-aviation-coatings-aa4515/>

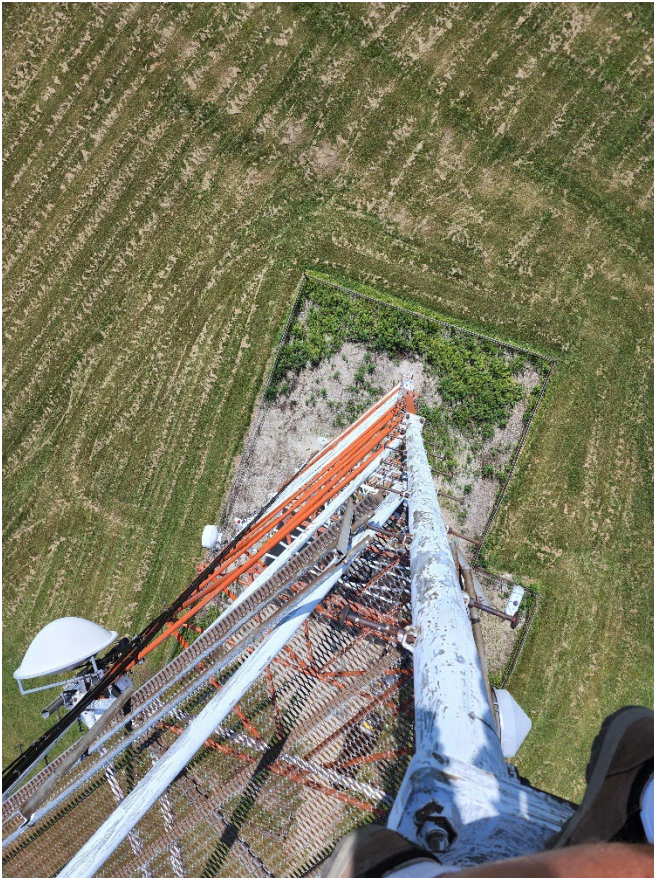
Paint condition poor

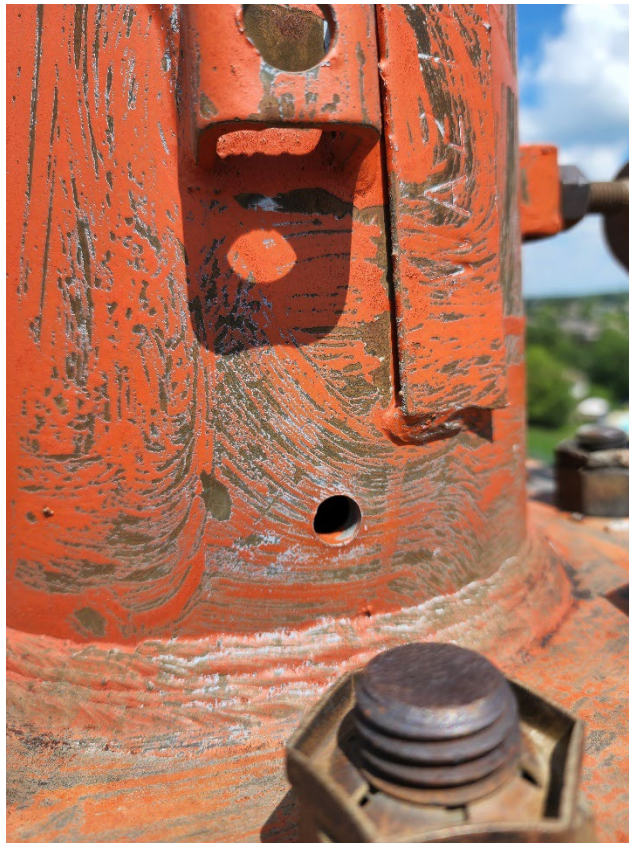
3. **Cable ladders and lighting conduit usually will rust** before structural steel. There is a considerable amount of rusting of these components on this tower and it is suggested to coat them while coating the tower.

4. Hardware such as bolts, washers and nuts can rust. There is a considerable amount of rusting of these components on this tower and it is suggested to coat them while coating the tower.

Paint condition is poor, galvanized rust bleed & hardware rust is plentiful

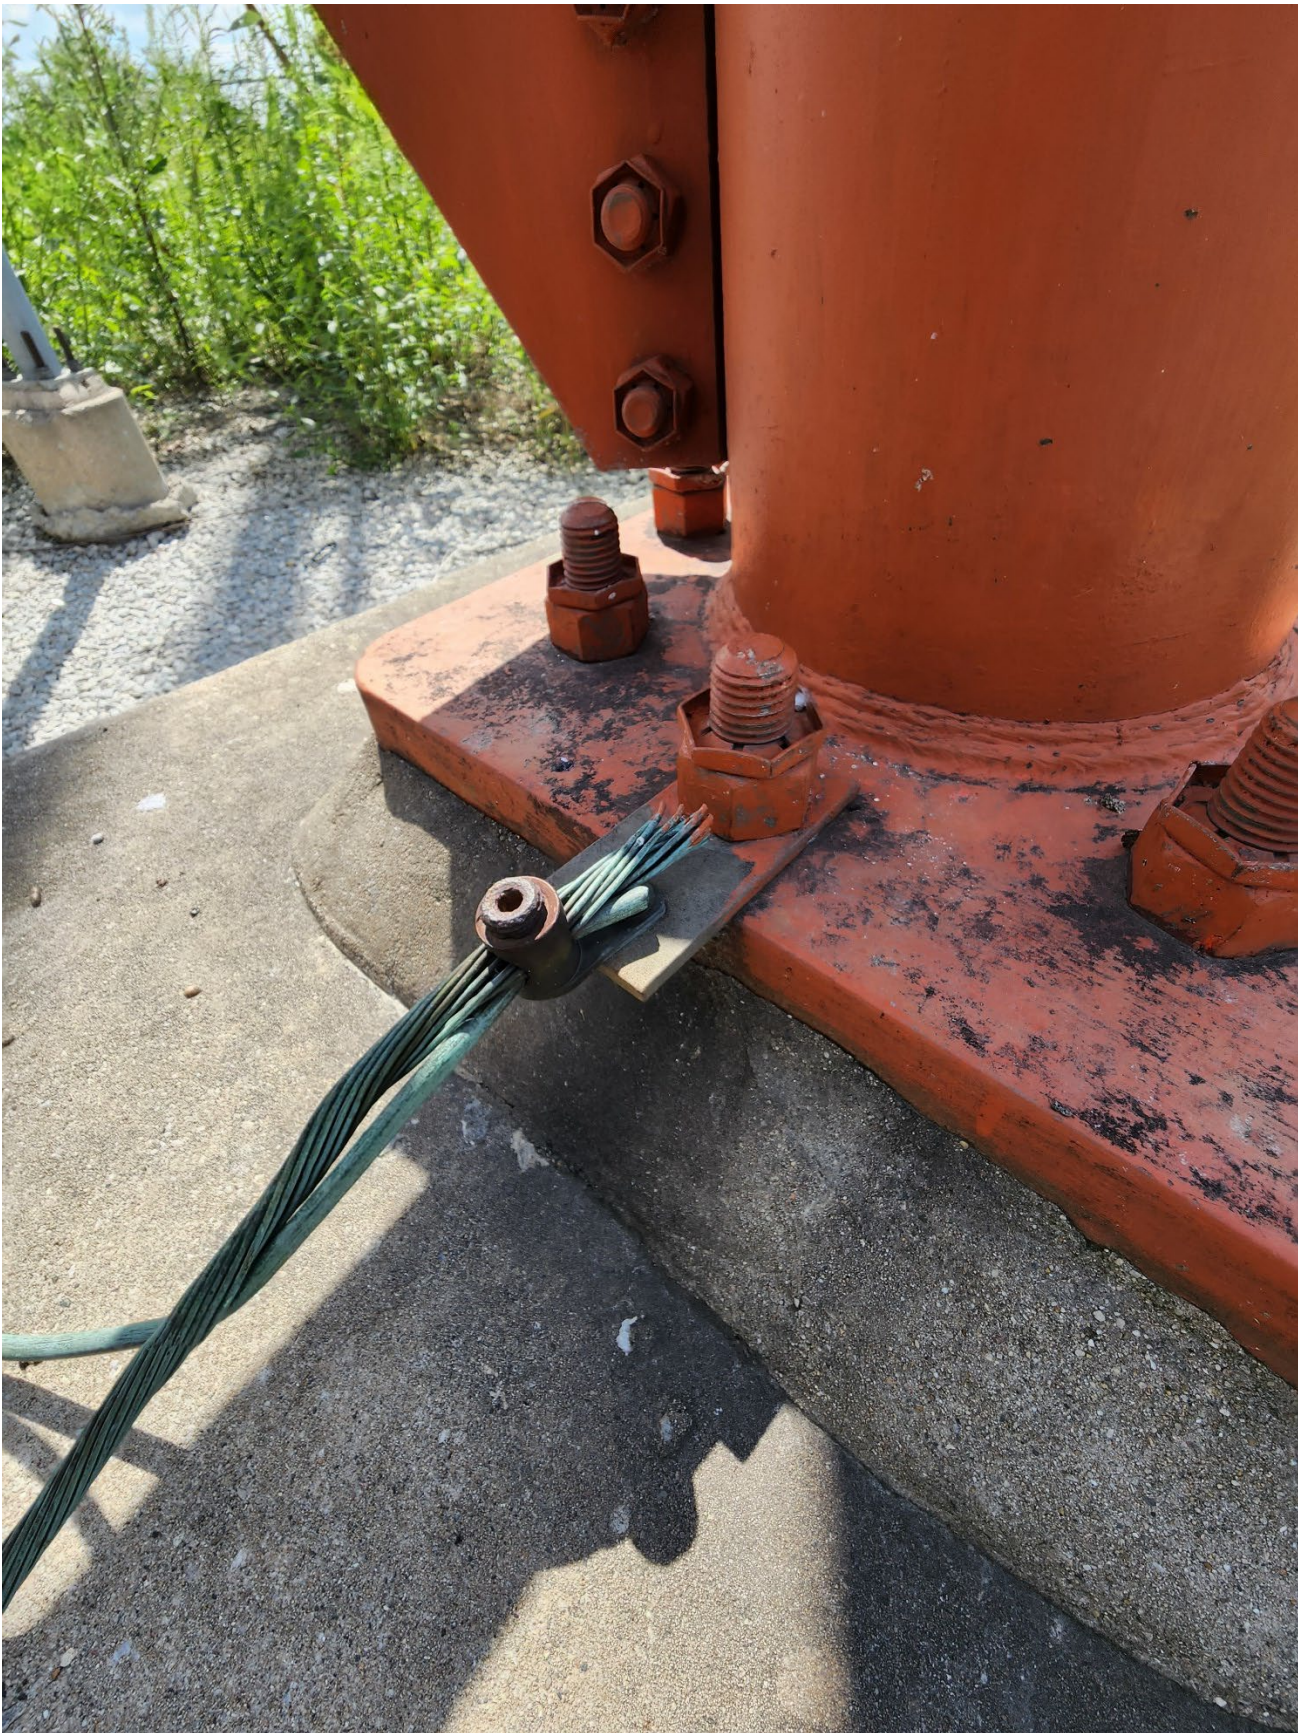
Issue 3 – base grounds needs to be cadweled

a. Flasher	OK	
b. Photo Control	OK	
c. Alarms	NA	
5 Light Lenses	OK	
6 Bulb Conditions	OK	
D. Grounding		
1 Connections checked and secure	Issue 3	Tower main base connections should be cadwelded
2 Corrosion observed	OK	
3 Lightning protection secure	OK

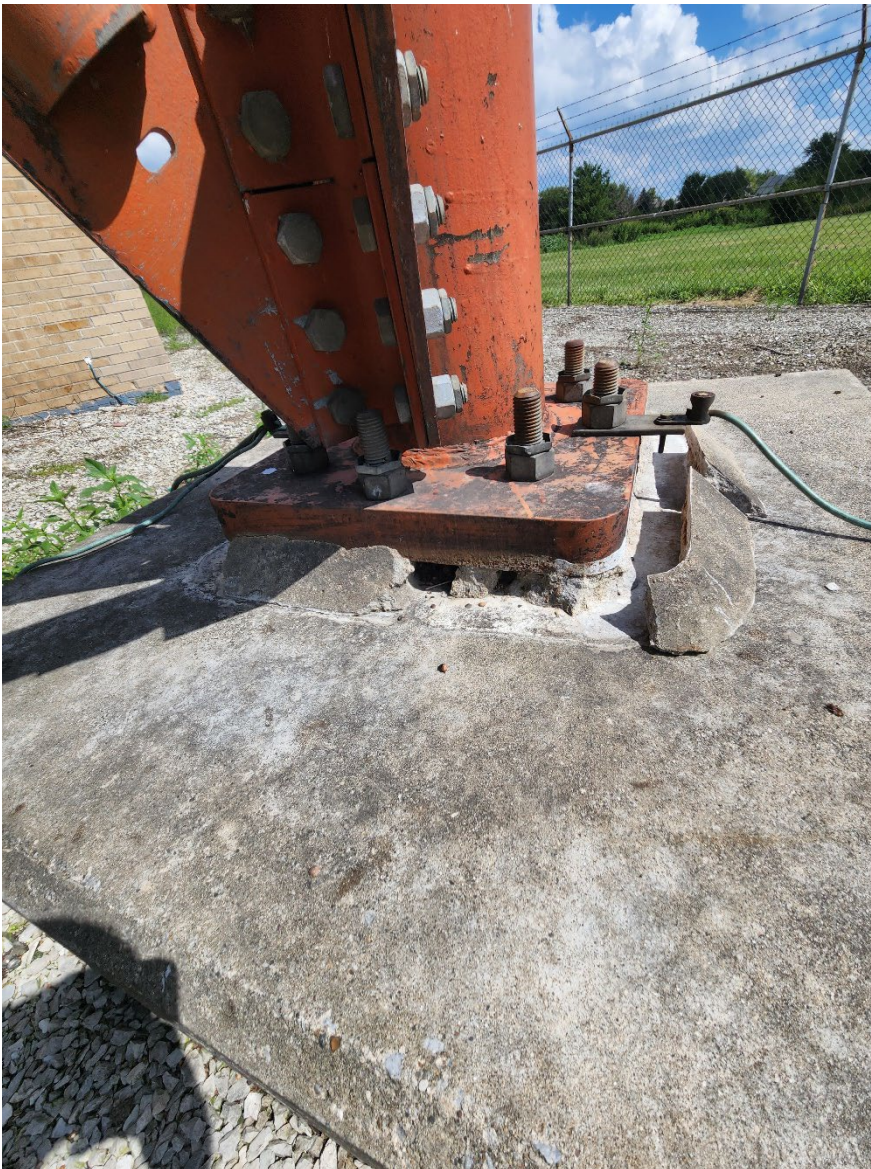
Issue 4 Grout needs repair

Item	Condition	Notes
2 Base Conditions		
a. Nuts & lock nuts tight	OK	
b. Grout condition	Issue 4	Grout is cracked and/or missing. We suggest this be repaired.
3 Concrete Conditions		
a. Cracking, spalling, or splitting	OK	
b. Chipped or broken concrete	OK	
c. Honeycombing	OK	
d. Low spots to collect moisture	OK	
e. Anchor-bolt corrosion	Issue 5	We suggest an ancho bolt inspection be performed.
F. Tower Alignment and Twist and Plumb	OK

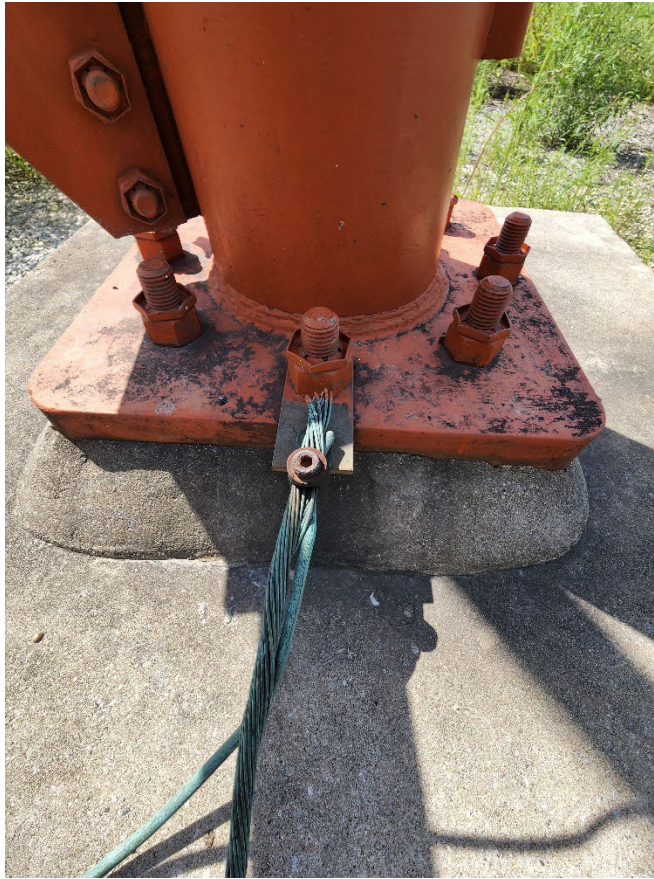
6. **Anchor bolt rot.** Recently there has been tower failures due to anchor bolt rot between the tower foundation and base section due to grout trapping water (which on a pipe leg tower drains down the inside and exits through drain holes in the grout). It is my suggestion a section of grout be removed to reveal the anchor bolts that have been buried since the tower was erected and inspected for rust.

Issue 5 Anchor bolt inspection, water could be getting trapped

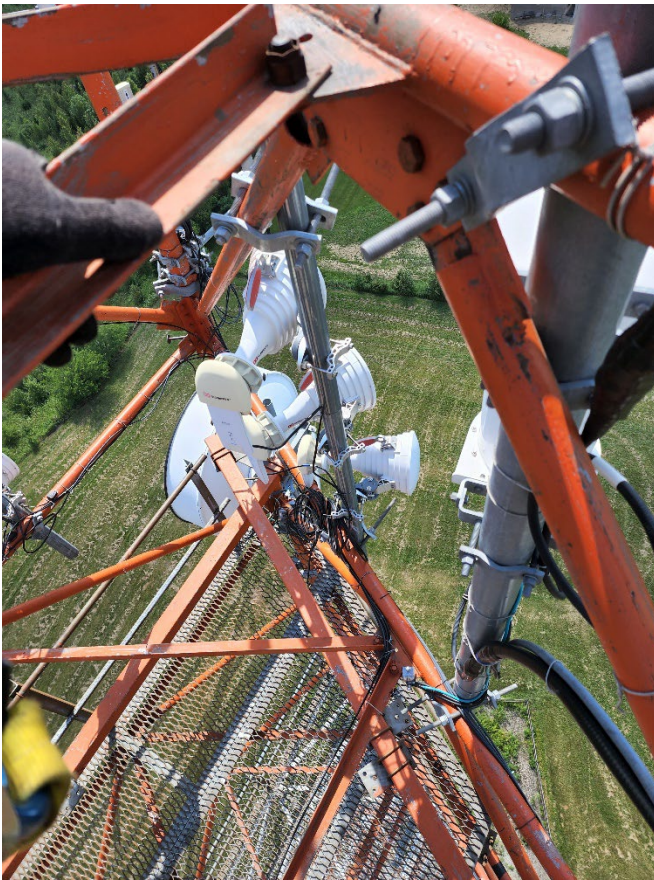
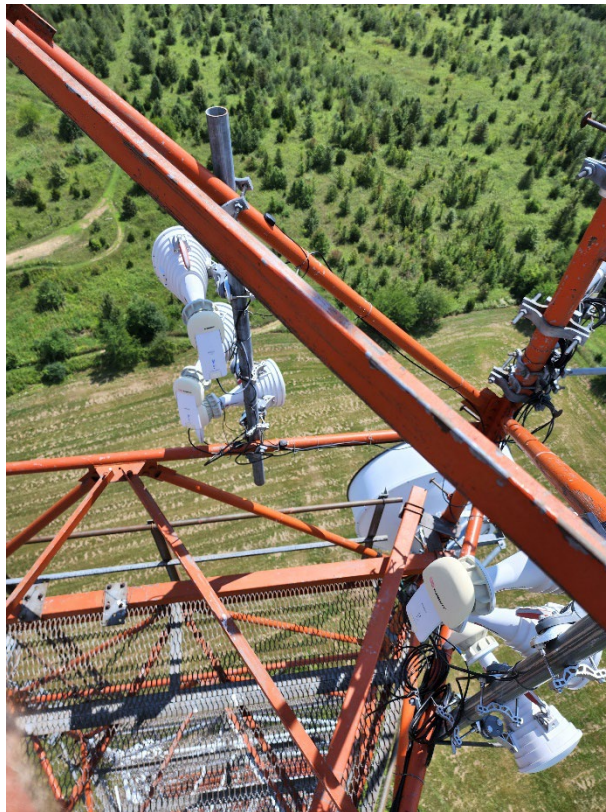
Issue 6 – wi fi clamps should be Valmont Pucks or cross over clamps

Issue 6 wi fi clamps should be replaced

Item	Condition	Notes
III. Antennas and Feedlines		
A. Antenna Mounts and Antennas		
1 Members (mounting and stabilizing)		
a. Bent, broken, or cracked	OK	
b. Loose -	ISSUE 6	Wi-Fi mounts secured with substandard clamps, suggest crossovers be utilized. https://www.sitepro1.com/store/cart.php?m=product_detail&p=1999

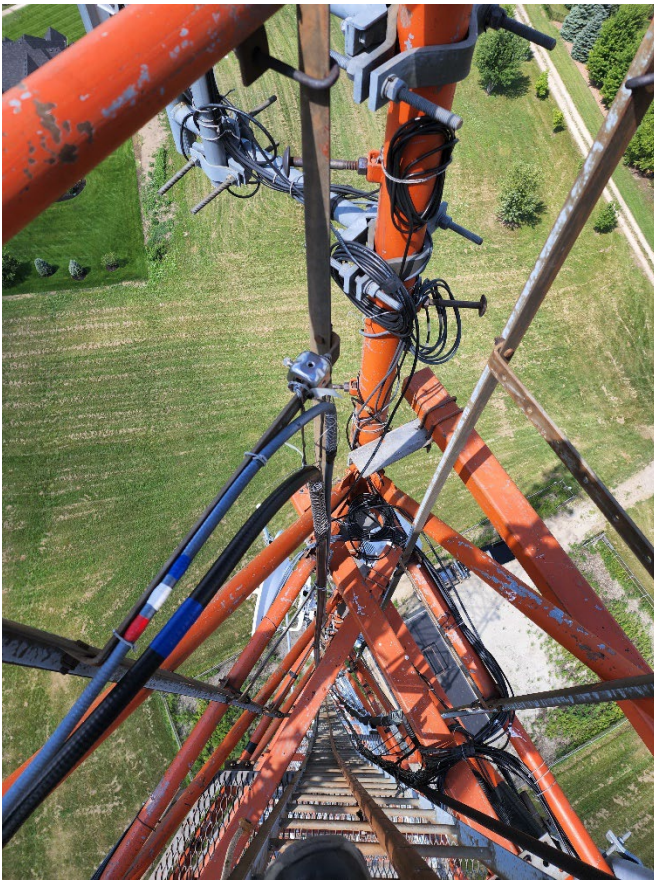
Issue 7 – wi fi quality, poorly supported wires, many unused

a. Condition	OK	
b. Quality	Issue 7	Much all the Wi-Fi antenna cabling is hap-hazardly installed and needs to be neatly re-supported.
c. Corrosion condition	OK	
2 Flanges and seals (check integrity)	OK	
3 Line Condition

a. Properly attached	Issue 7	Much all the Wi-Fi antenna cabling is poorly installed and needs to be neatly re-supported.
b. Loose and/or missing bolts	OK

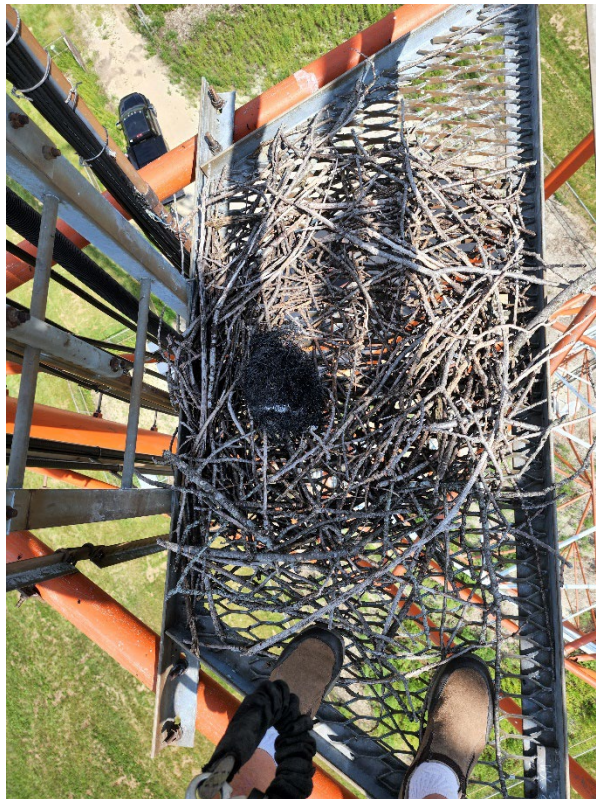
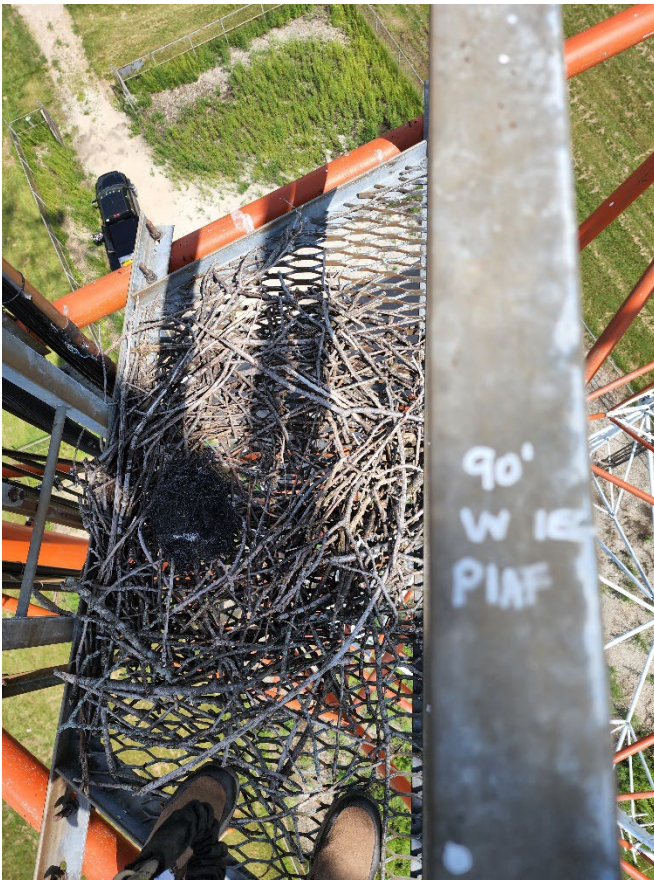
Issue 8 – hawks Nest @ 90', monitor as needed

Issue 8 Hawks nest @ 90' Climbing leg

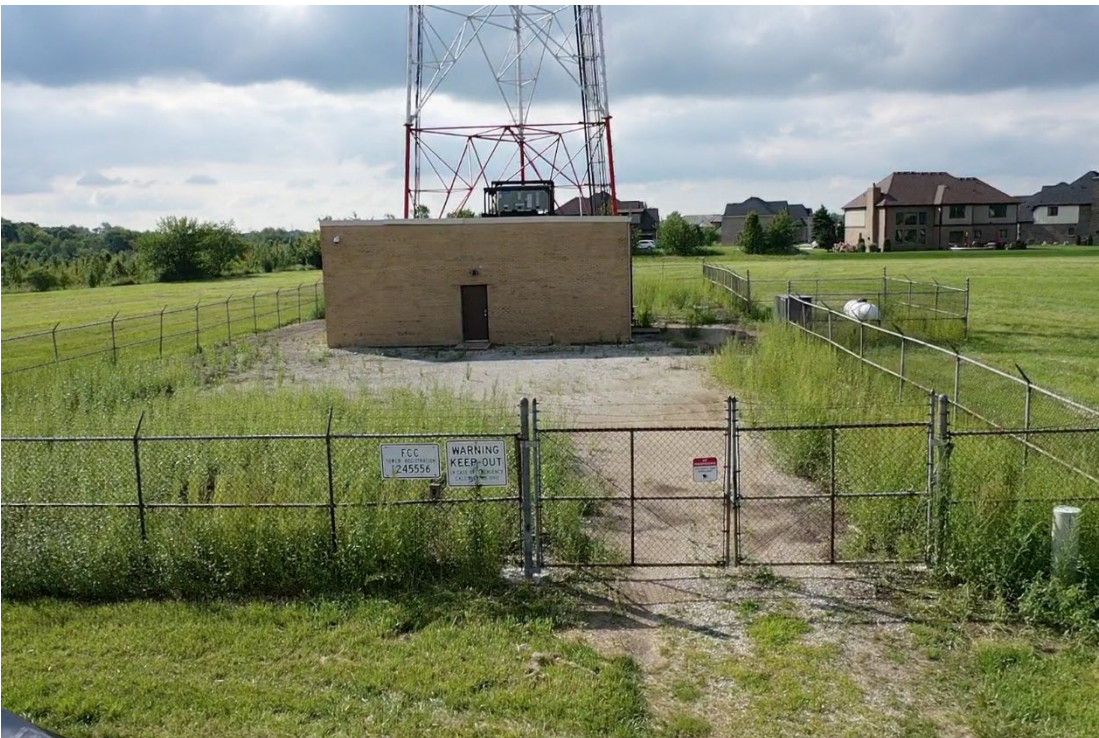
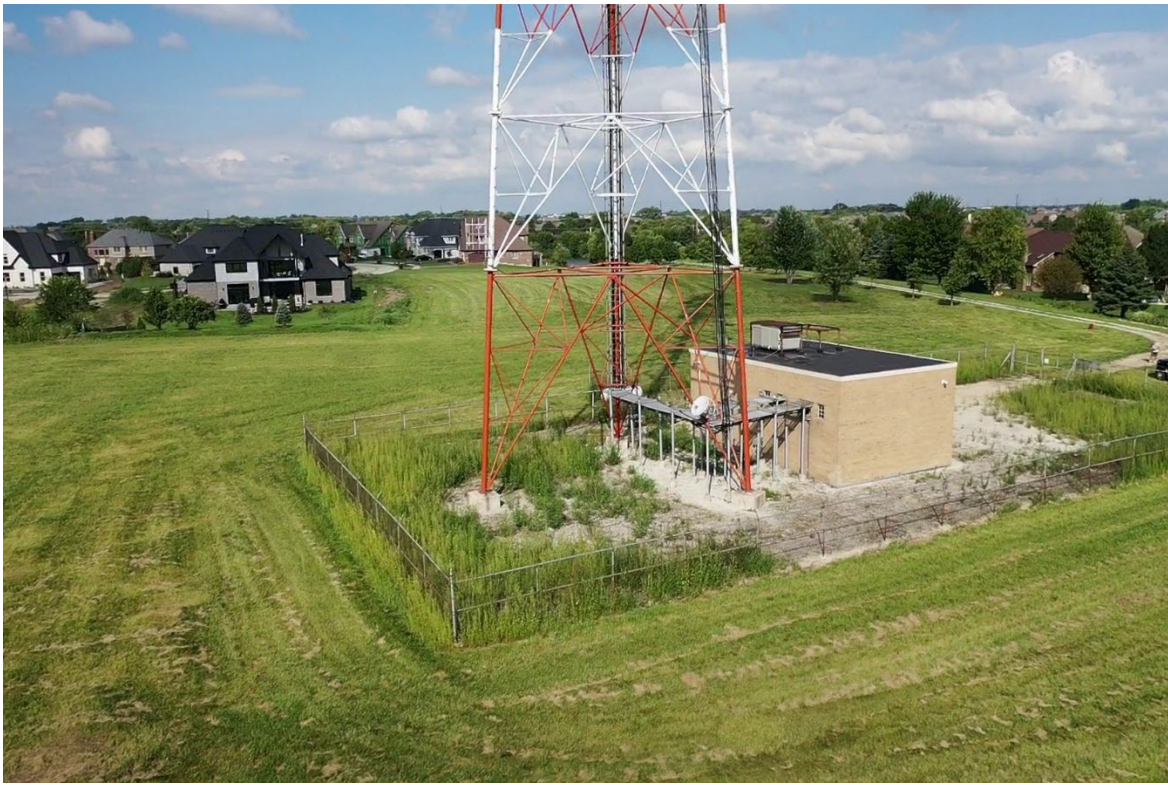
Issue 9 Weed Control needed, not just periodic spraying but a full soil neutralization program with quarterly sprays

Issue 9 Weed Control

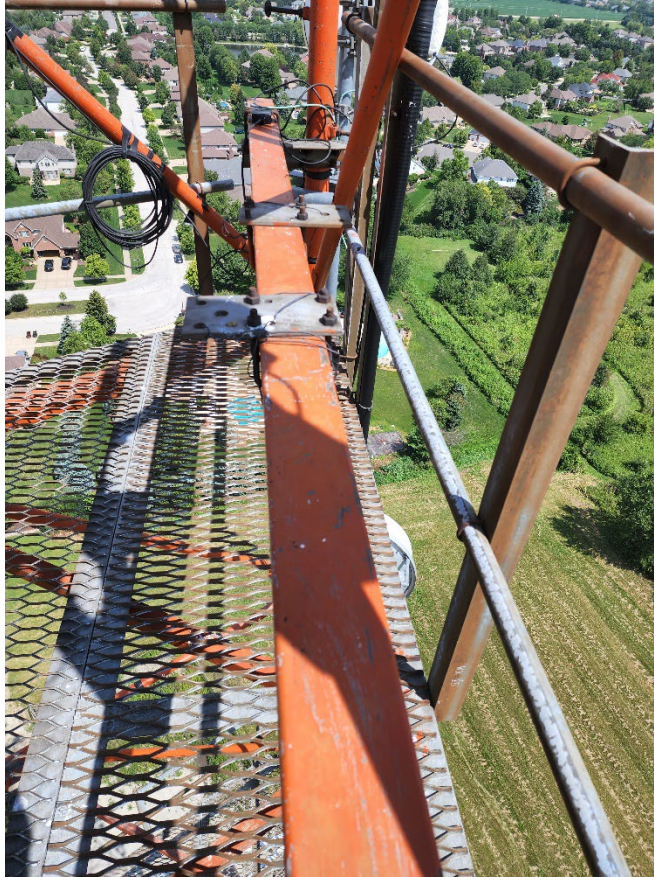
Issue 10 – removal of old equipment (mounts, tie backs, cables etc.)

Tower	10	Equipment removal	We suggest removing unused equipment from the tower	Issue 10
Tower	11	Missing step bolts x 12	There are missing step bolts, we suggest installing new step bolts in all missing spaces	Issue 11
